Onan 2800 Micro Lite Generator Model KV Spec K

I would like to share the saga of my Onan Generator with the Road Trek Community. I have owned a 2005 210 Popular since September 2004. The motor home is constructed on the Chevy 3500 Express Van Chassis. I currently have 133,000 miles on motor home and 503 hours on the generator.

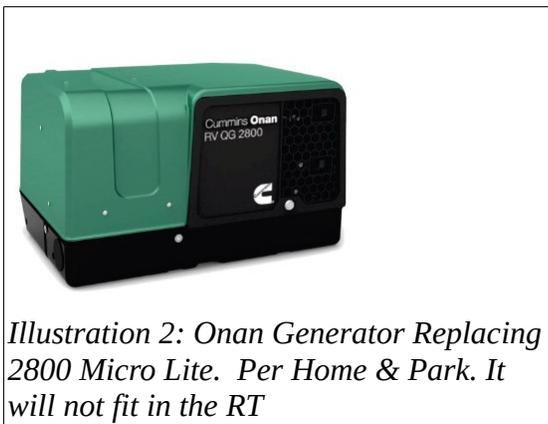
Fast forward 3 years. I decided to revisit the generator issue. June 2016 I figured I would throw in the towel and purchase a replacement unit. The original 2800 Onan Micro lite KV model was no longer in production. I called several Onan internet sources and was advised the model below is the replacement.

The specs on line indicated the bolt pattern is different and would not properly line up with the existing bracket under the motor home. I called Road Trek service department and was advised the new version would not fit. I asked if there were replacement brackets available. I was told no. Considering Road Treks have a long useful life with a loyal user base an answer of no seemed a bit short sighted. I was advised to check with the Cyberrally resources to see what I could

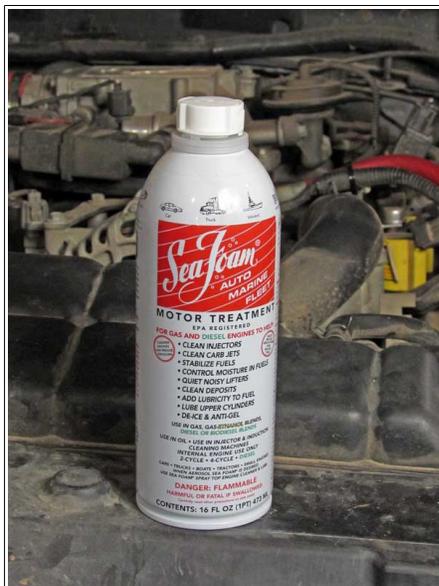
Illustration 3: Sea Foam

Back to my existing generator. It sat neglected for three years. I attempted to start it. It did fire up but would not continue to run. I figured the carburetor was the problem. I purchased a can of Sea Foam fuel treatment and added it to the gas container. The generator ran long enough to draw new fuel with the Sea Foam into the carburetor. I let it sit overnight and

restarted using starting fluid to encourage it to run a few minutes. I repeated the process for 3 days. I was making progress but decided to remove the carburetor to clean it. The generator still would not run

- 5). I plan to add Sea Foam to the motor home fuel tank periodically to aid in keeping the carburetor working properly. It should also aid in keeping the fuel injectors and vehicle engine components clean. (I believe Sea Foam or something similar is what is recommended by auto service centers to "clean" your fuel system. They charge about \$100.00 for the treatment. A can of Sea Foam is about \$10.00. Currently Advance Auto has it on sale buy one and get the 2nd one 50% off).

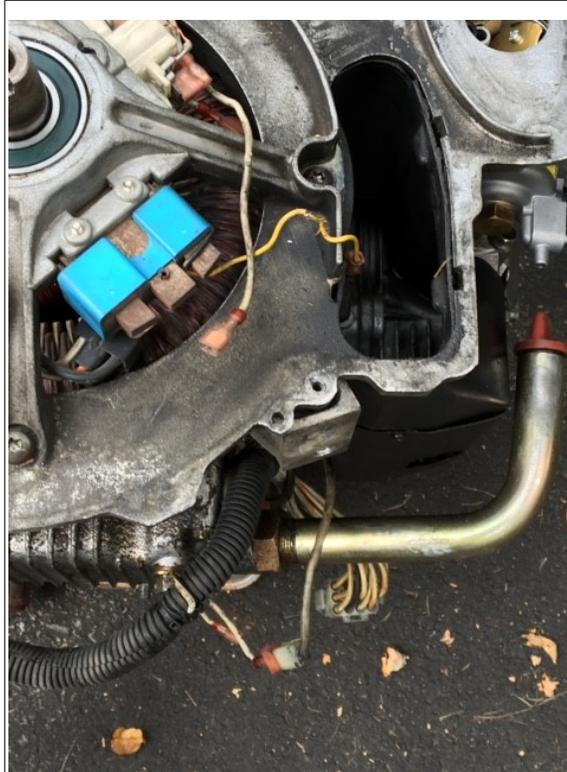
Illustration 4: Magneto in aqua. Yellow wire severed.

Installed it and WOW, the generator started virtually instantly and ran smoothly. I let it run a few minutes, shut it down, restarted it. I ran the power cord to the RT and turned on the A/C. It ran perfectly. I left the generator running and went off to lunch. I figured I would treat myself (I hope I am not boring you to death) to a nap in a nice air conditioned motor home after lunch with the lovely hum of the generator in the background. Arriving home the generator was silent and pretty well cooled down. There went the nap out the window. I tried starting it. Nothing. I checked for a spark. None. I was hoping the low oil level sensor was defective causing a shut down. I disconnected it. Still no spark. Tracking back it appeared to be a magneto problem.

The magneto is under the fan housing that is bolted to the rotor. In order to get to it much of the generator has to be disassembled. I pulled the fan from the rotor shaft using a harmonic balance puller. (There is a very small woodruff key at the end of the shaft. It is labeled as "alignment key" in illustration 6) Do not lose it). The yellow wire from the magneto to the coil was severed. Apparently when the generator was reassembled 3 years ago 2 wires were routed incorrectly. The fan wore through the wire cutting off current from the magneto to the coil. I stripped the wire back, soldered it together and put shrink wrap over it routed it correctly and

reassembled it. It immediately started. It has run successfully for about 10 hours in pretty extreme heat here on the east coast.

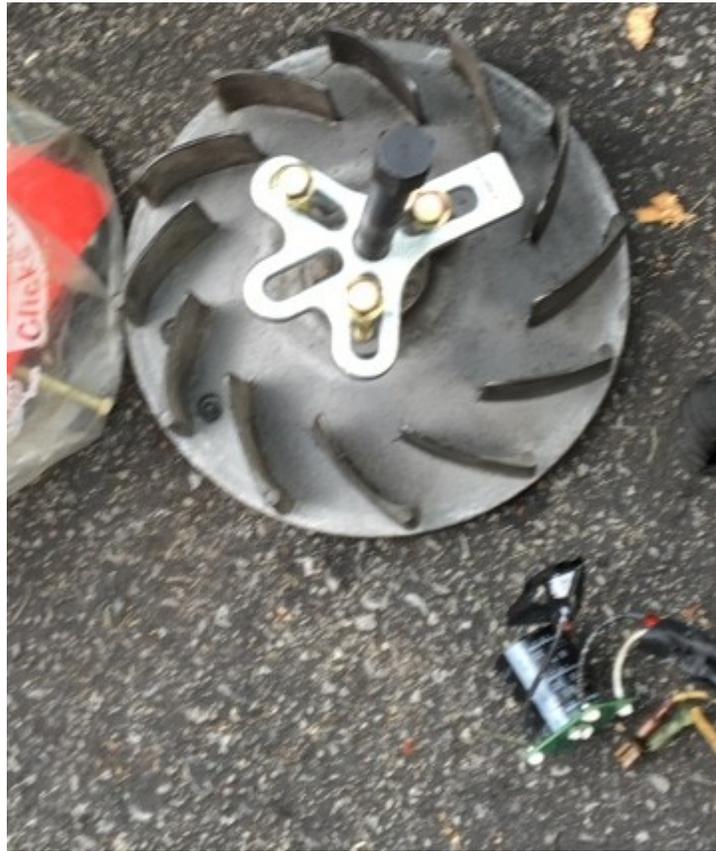
Illustration 5: Fan Hub Assembly with Harmonic Balance Puller attached

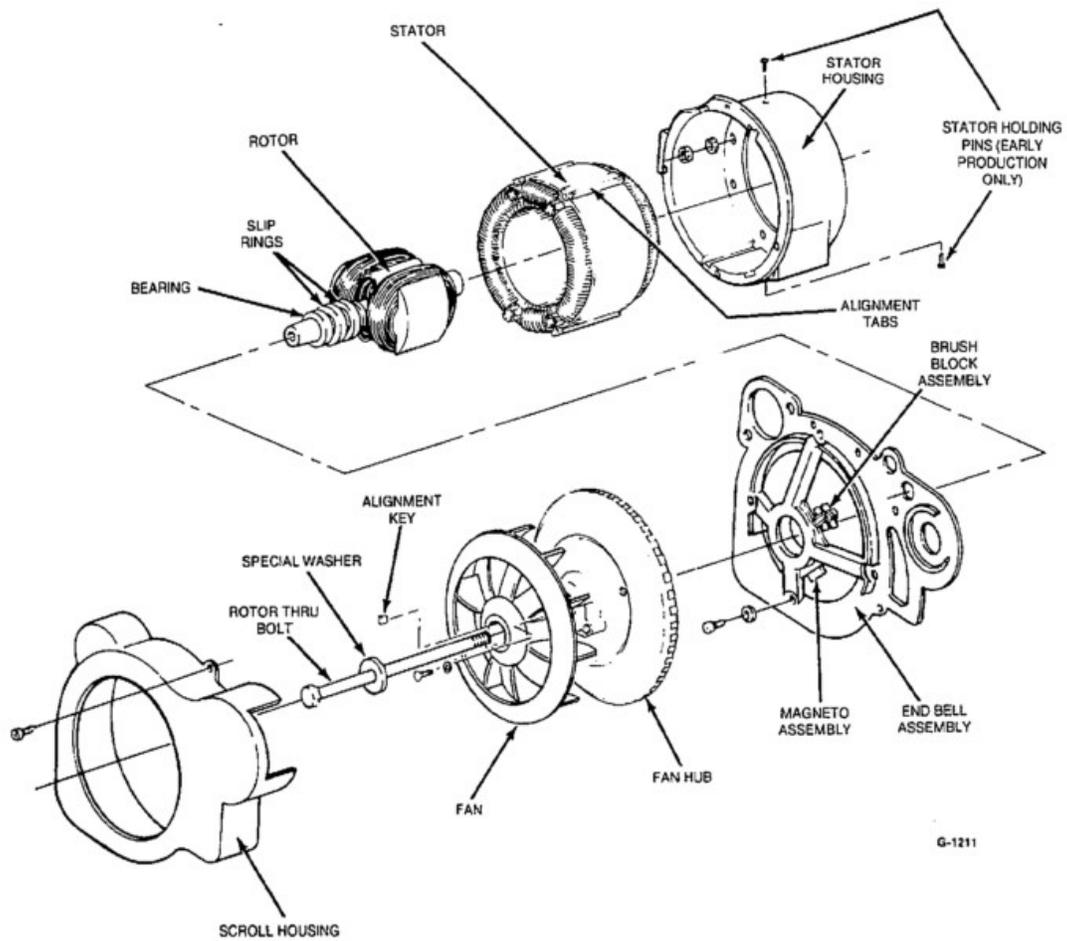
Illustration 6: Schematic from Service Manual showing Fan, Rotor, Stator, Magneto etc assembly

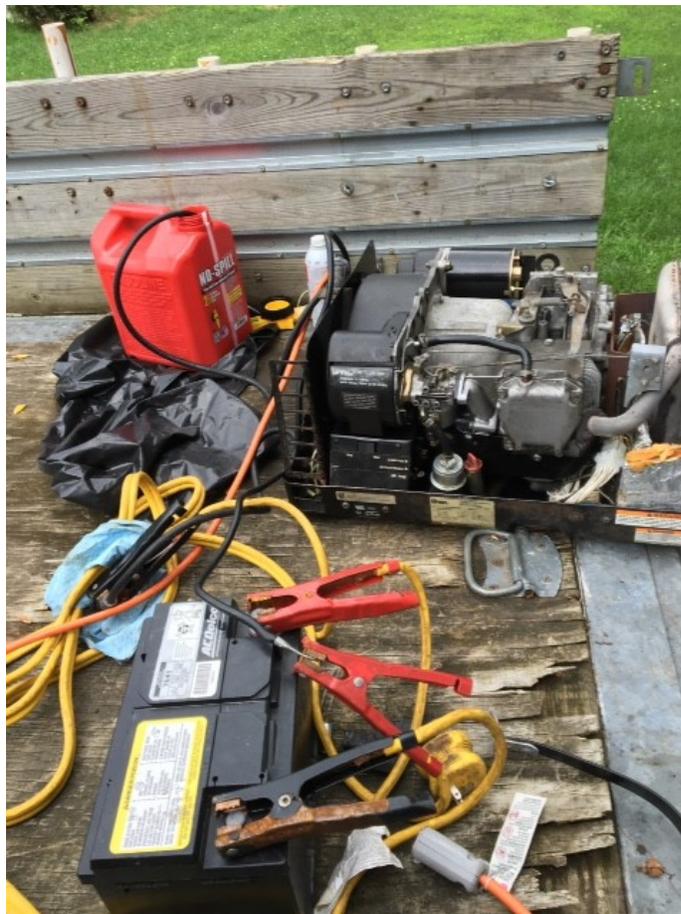
Illustration 7: Generator on "work bench" Orange cord replaced wire whip. Fuel line approximately 3' long. Positive cable (red clamps) is 51" in length. Voltage regulator is to the right under the white bundle of wires only accessible with generator out of MH and cover off. Coil and spark plug wire is in the same area. The on off remote switch is to the left and held in place with 2 torx studs. The fuel filter is to the right of remote start. Not easily serviceable. The oil dip stick and fill is to the right of the filter.

The extension of the wires and fuel line was pretty basic. The 120 Volt wire coming from the motor home to the generator was a wire whip. The whip had little excess length to allow for disconnection. I found it necessary to cut the wires.

The fuel line was a simple disconnect. You have to pinch it off then remove it from the steel fuel line coming out of the vehicle gas tank. The wire running from the starter to the motor home positive wire was also very short. It is two cables bolted together. One cable from the generator and the other from the positive side of the vehicle battery. They are above the generator and covered with insulation. I had to cut the insulation to unbolt it. The remote control cable from the inside the motor home is a quick disconnect that you have to fish around to find then disconnect. I removed the wire whip from the generator and purchased 10 feet of 12/3 orange extension cord. I wired the cord to the generator where the wire whip had been wired. I put a female heavy duty extension cord end on the extension cord coming from the generator. I attached a male heavy duty extension cord end to the wires that had been attached to the whip coming from the motor home. I now have a quick connect extension cord system with 10 feet of cord (a bit of an over kill but it might be useful if I need to use the generator as auxiliary power for something. I can just uncoil the cord from under the MH and use it outside the MH). I replaced the fuel line with 3' of 1/4" line . The fuel line is clamped to a steel line on the fuel pump and clamped to the line exiting the gas tank. I replaced the cable from the starter to the positive of the motor home with 51" 4 gauge battery cable. I bolted the two wires together as they had been before then wrapped with electrical tape. The generator can easily be removed without fighting with the short wires and fuel lines. The only one I did not touch is the quick connect. It is not that hard to fish out.
